NESQUEHONING 4TH HOLLOW RESERVOIR

NDI NO. PA-00806
DER NO. 13-104

**PHASE I INSPECTION REPORT
NATIONAL DAM INSPECTION PROGRAM**

Berger Associates, Inc.
Harrisburg, Pennsylvania

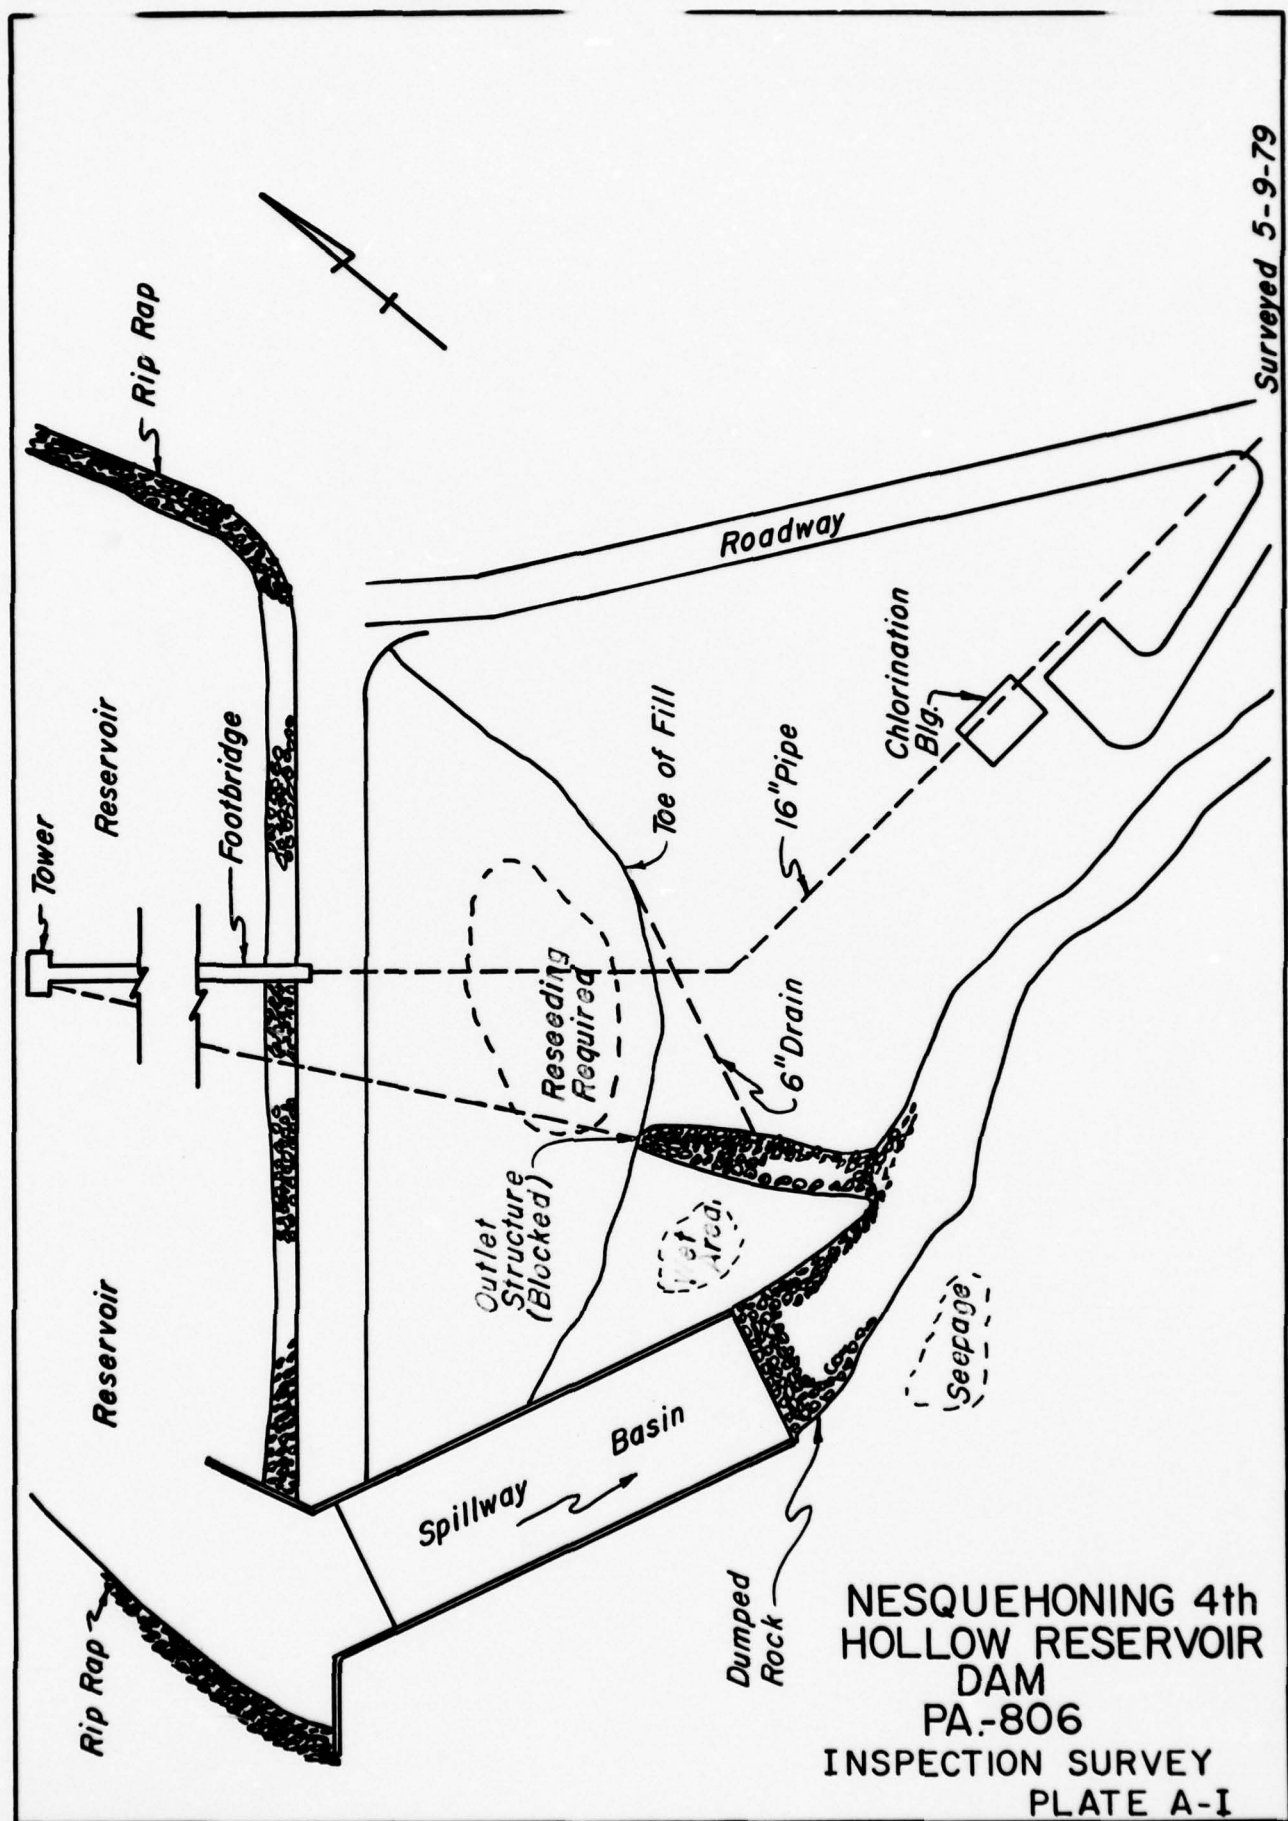
NESQUEHONING 4th
HOLLOW RESERVOIR
DAM
PA-806
INSPECTION SURVEY
PLATE A-II

The upstream slope was in excellent condition and well protected with heavy riprap. The breast of the dam was level and above the spillway walls (Plate A-II, Appendix A), and covered with gravel. The downstream slope has little or no vegetation in several places, mainly caused by trail bikes. The Borough has installed several fences to discourage this misuse of the facilities. The Borough representative stated that reseeding of the barren spots was planned.
